Camp Shelby, Mississippi

Evaluation CCTV Inspection Report for Sanitary Sewer Main Improvements

CCTV INSPECTION REPORT: Vol. 8

Suncoast Job #: 557

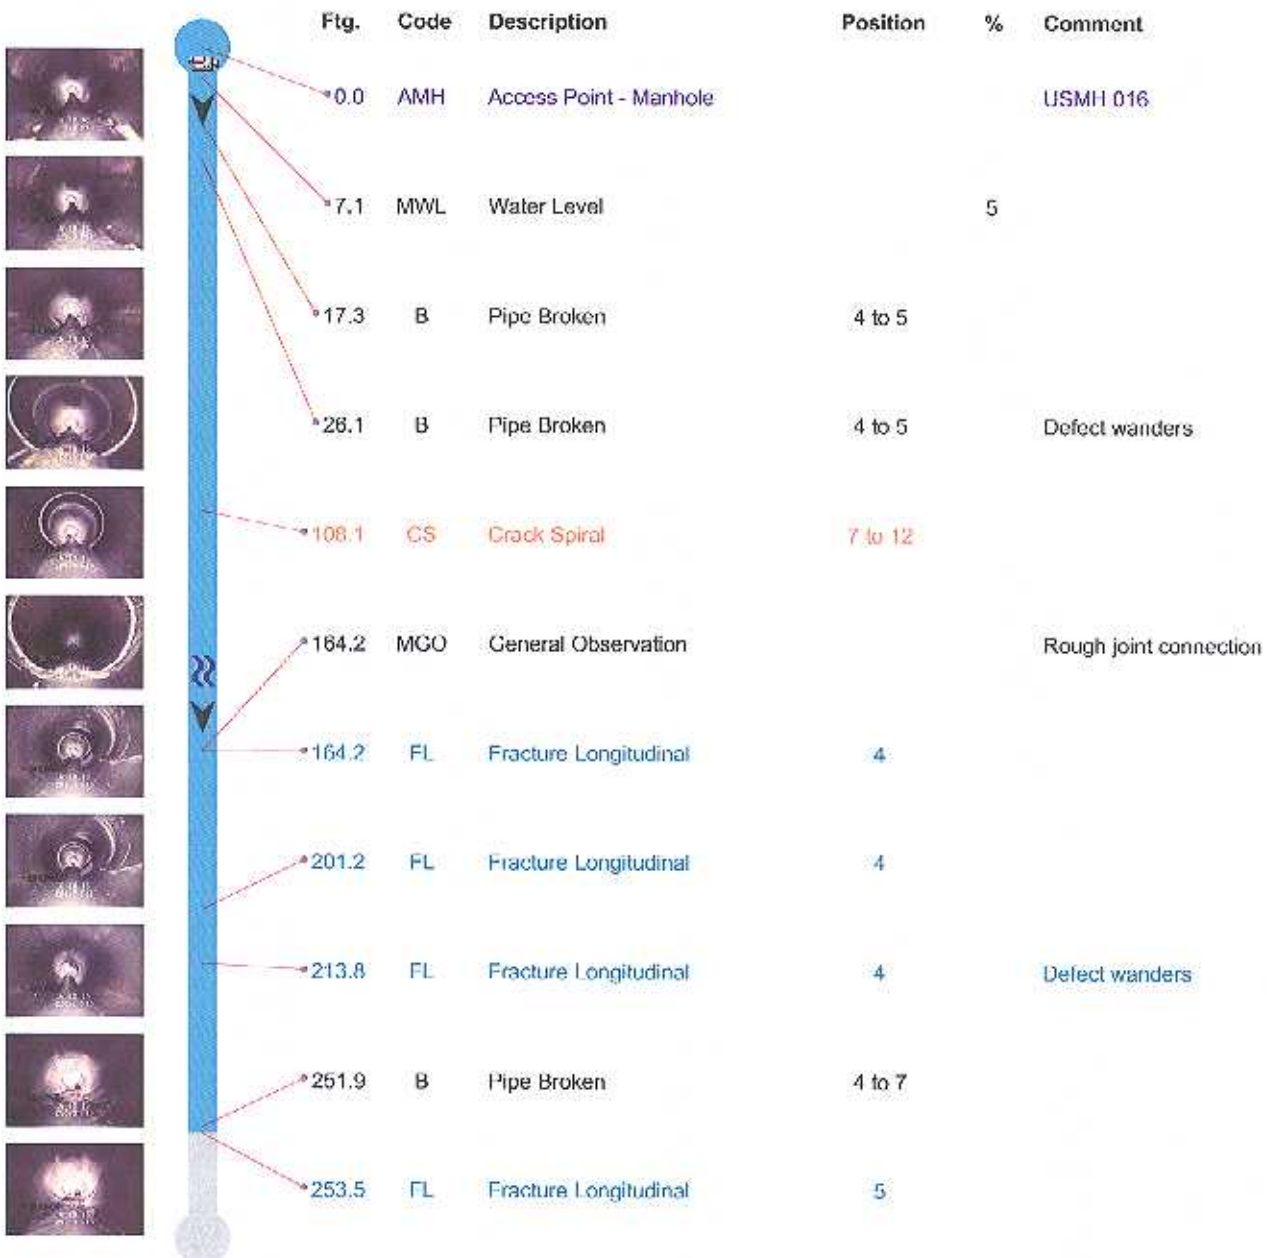
U: 016

Surveyors name Suncoast/MB	Certificate Number 02-060	System Owner City of Camp Shelby	Survey Customer City of Camp Shelby	Drainage Area	Sheet 1				
PIO No. 557	Pipeline Segment Reference 016 - 015	Date 1/3/2006	Time 12:00:00 AM	Location (Street Name and number) In Passerent	Locality Camp Shelby, MS				
Further Location details		Upstream Manhole Number 016	Rim to Invert 6.33	Grade to Invert	Rim to Grade				
Downstream Manhole Number 015	Rim to Invert 7	Grade to Invert	Rim to Grade	Use of Sewer Sanitary	Direction Downstream	Flow Control De-Watered using Jetter	Height 15		
Width 15	Shape Circular	Material Polyethylene	Ln. Method	Pipe Joint Length 44	Total Length 280	Length Surveyed 278.1	Year Laid	Year Rehabilitated	Media # / VTR Start Tape 1024
Purpose Infiltration/Inflow Investigation	Sewer Category	Pre-Cleaning Heavy Cleaning	Cleaned 1/3/2006	Weather Dry	Additional Information VHS# 01:45:24. Pipe has been lined

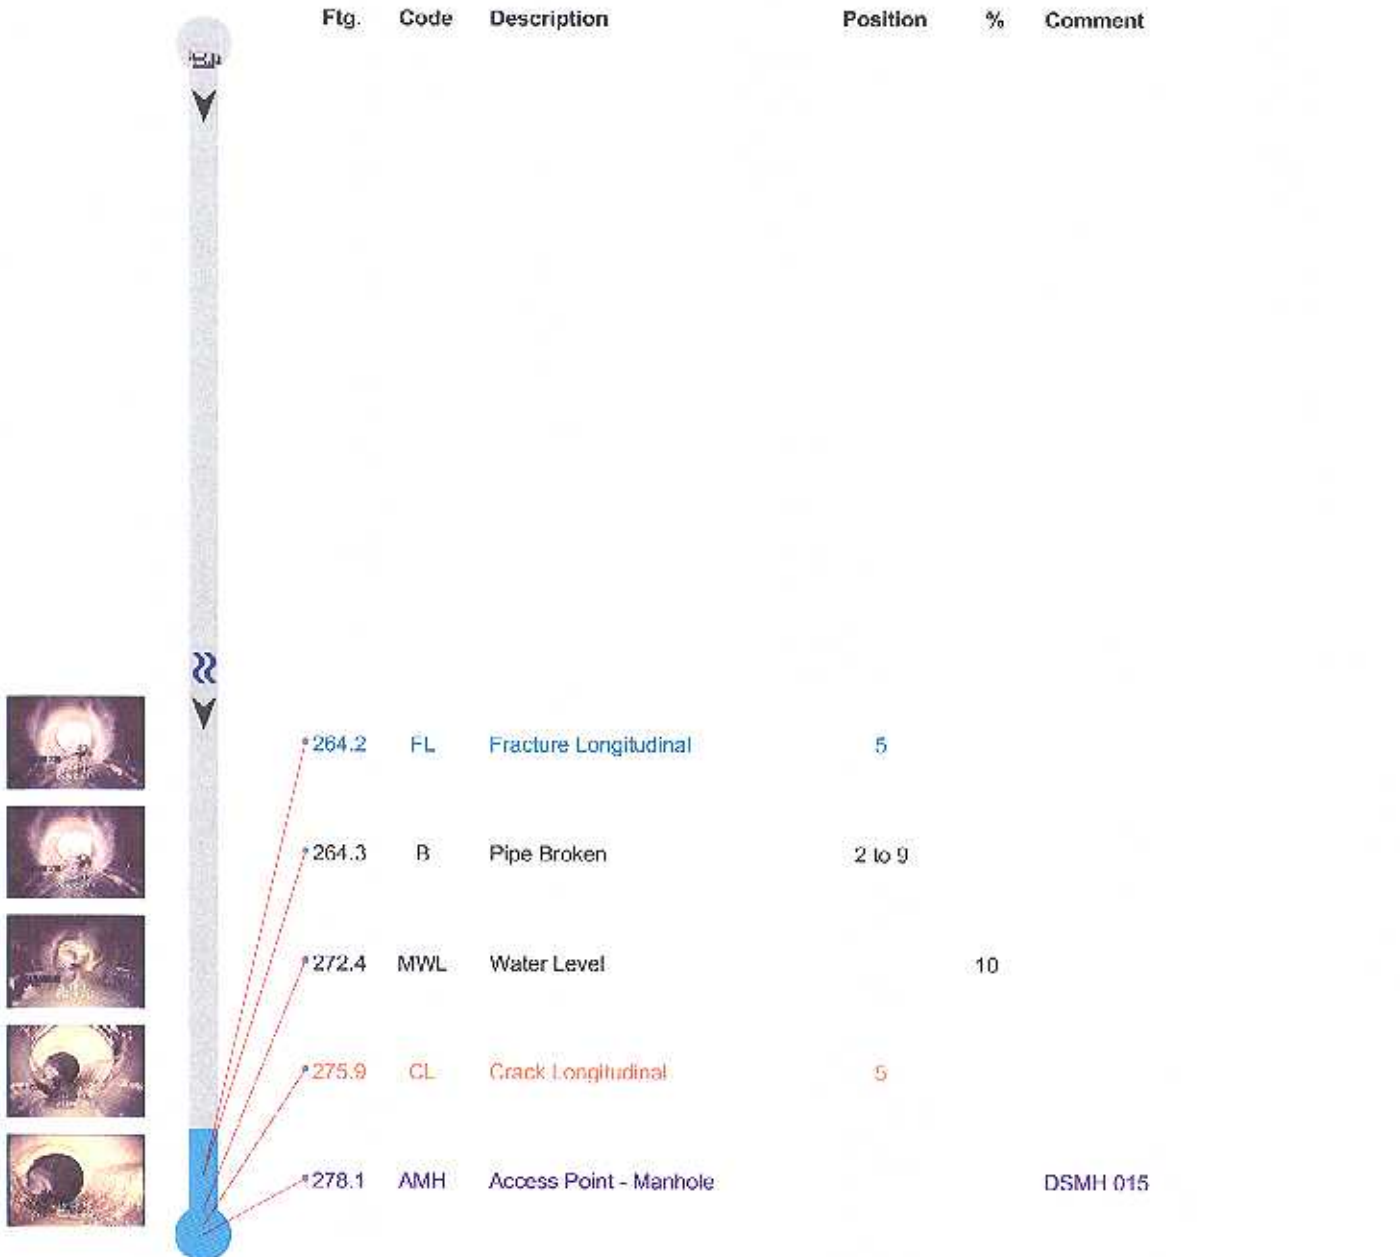
U: 016

Surveyors name Suncoast/MB	Certificate Number 02-060	System Owner City of Camp Shelby	Survey Customer City of Camp Shelby	Drainage Area	Sheet 2				
PIO No. 667	Pipeline Segment Reference 016 - 015	Date 1/3/2006	Time 12:00:00 AM	Location (Street Name and number) In Fessenden	Locality Camp Shelby, MS				
Further Location details		Upstream Manhole Number 016	Rim to Invert 8.33	Grade to Invert	Rim to Grade				
Downstream Manhole Number 015	Rim to Invert 7	Grade to Invert	Rim to Grade	Use of Sewer Sanitary	Direction Downstream	Flow Control De-Watered using Jetter	Height 15		
Width 16	Shape Circular	Material Polyethylene	Ln. Method	Pipe Joint Length 44	Total Length 200	Length Surveyed 2/8.1	Year Laid	Year Rehabilitated	Media # / VTR Start Tape 1024
Purpose Infiltration/Inflow Investigation	Sewer Category	Pre-Cleaning Heavy Cleaning	Cleaned 1/3/2006	Weather Dry	Additional Information VHS# 01:45:24, Pipe has been lined

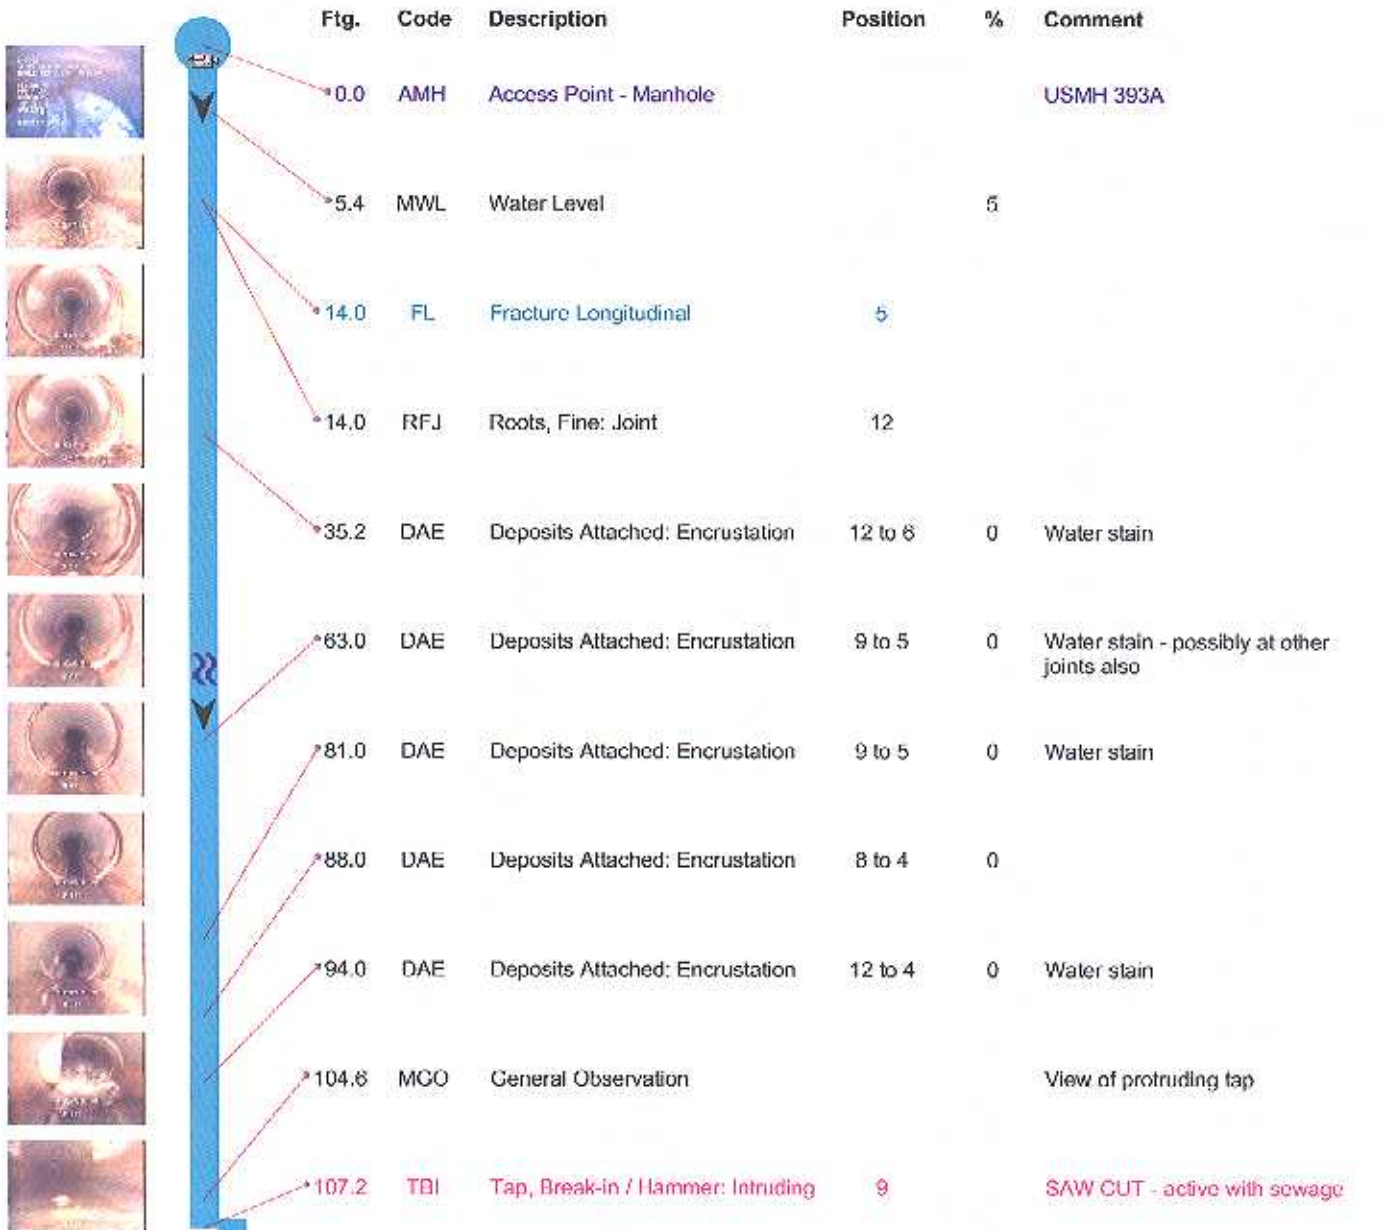
U: 393A

Surveyors name Suncoast/PY	Certificate Number 02-060	System Owner City of Camp Shelby	Survey Customer City of Camp Shelby	Drainage Area	Sheet				
PIO No. 557	Pipeline Segment Reference 393A - 393	Date 1/18/2008	Time 12:00:00 AM	Location (Street Name and number) 6th St.	Locality Camp Shelby, MS				
Further Location details Bldg. 510		Upstream Manhole Number 393A	Rim to Invert 10	Grade to Invert	Rim to Grade				
Downstream Manhole Number 392	Rim to Invert 5.67	Grade to Invert	Rim to Grade	Use of Sewer Sanitary	Direction Downstream	Flow Control Not controlled	Height 8		
Width 8	Shape Circular	Material Vitrified Clay Pipe	Ln. Method	Pipe Joint Length 8	Total Length 228	Length Surveyed 107.9	Year Laid	Year Rehabilitated	Media # / VTR Start Tape 3221
Purpose Infiltration/Inflow Investigation	Sewer Category	Pre-Cleaning Heavy Cleaning	Cleaned 1/16/2006	Weather Dry	Additional Information VHS# 00:48:01

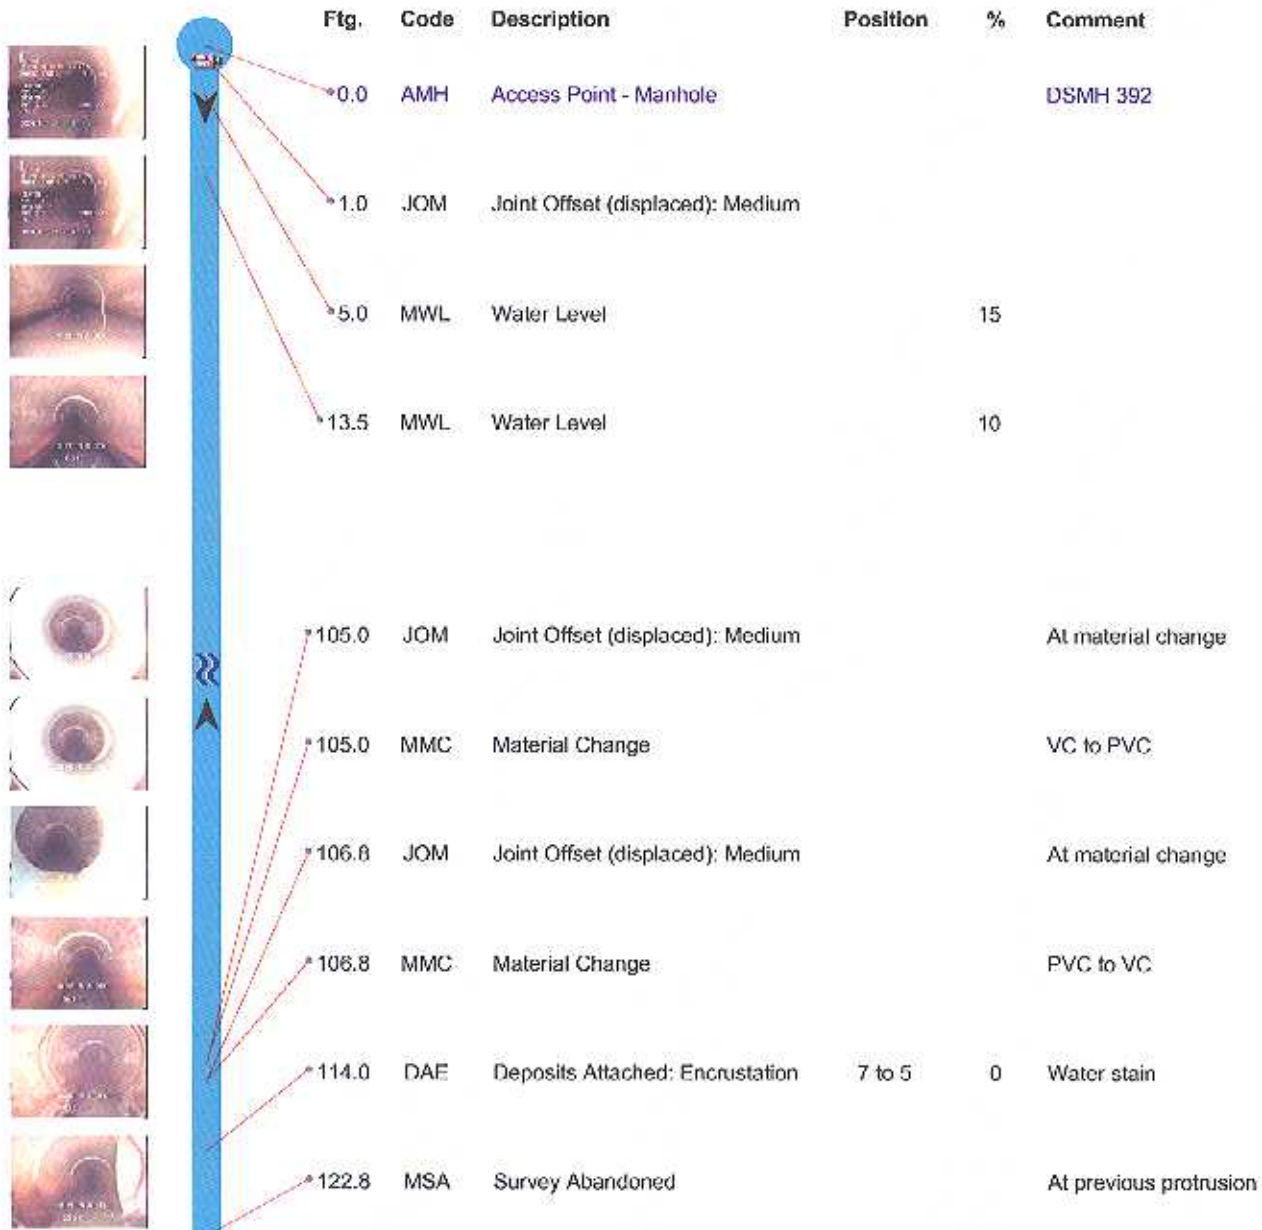
U: 393A

Surveyors name Suncoast/PY	Certificate Number 02-000	System Owner City of Camp Shelby	Survey Customer City of Camp Shelby	Drainage Area	Sheet				
P/O No. 557	Pipeline Segment Reference 393A - 392	Date 1/16/2006	Time 12:00:00 AM	Location (Street Name and number) 5th St	Locality Camp Shelby, MS				
Further Location details Bldg. 510		Upstream Manhole Number 393A	Rim to Invert 10	Grade to Invert	Rim to Grade				
Downstream Manhole Number 392uv	Rim to Invert 5.67	Grade to Invert	Rim to Grade	Use of Sewer Sanitary	Direction Upstream	Flow Control Not controlled	Height 0		
Width 8	Shape Circular	Material Vitrified Clay Pipe	Ln. Method	Pipe Joint Length 3	Total Length 228	Length Surveyed 122.8	Year Laid	Year Rehabilitated	Media # / YIR Start Tape 3221
Purpose Infiltration/Inflow Investigation	Sewer Category	Pre-Cleaning Heavy Cleaning	Cleaned 1/16/2006	Weather Dry	Additional Information VHS# 00:52:42, Reverse setup

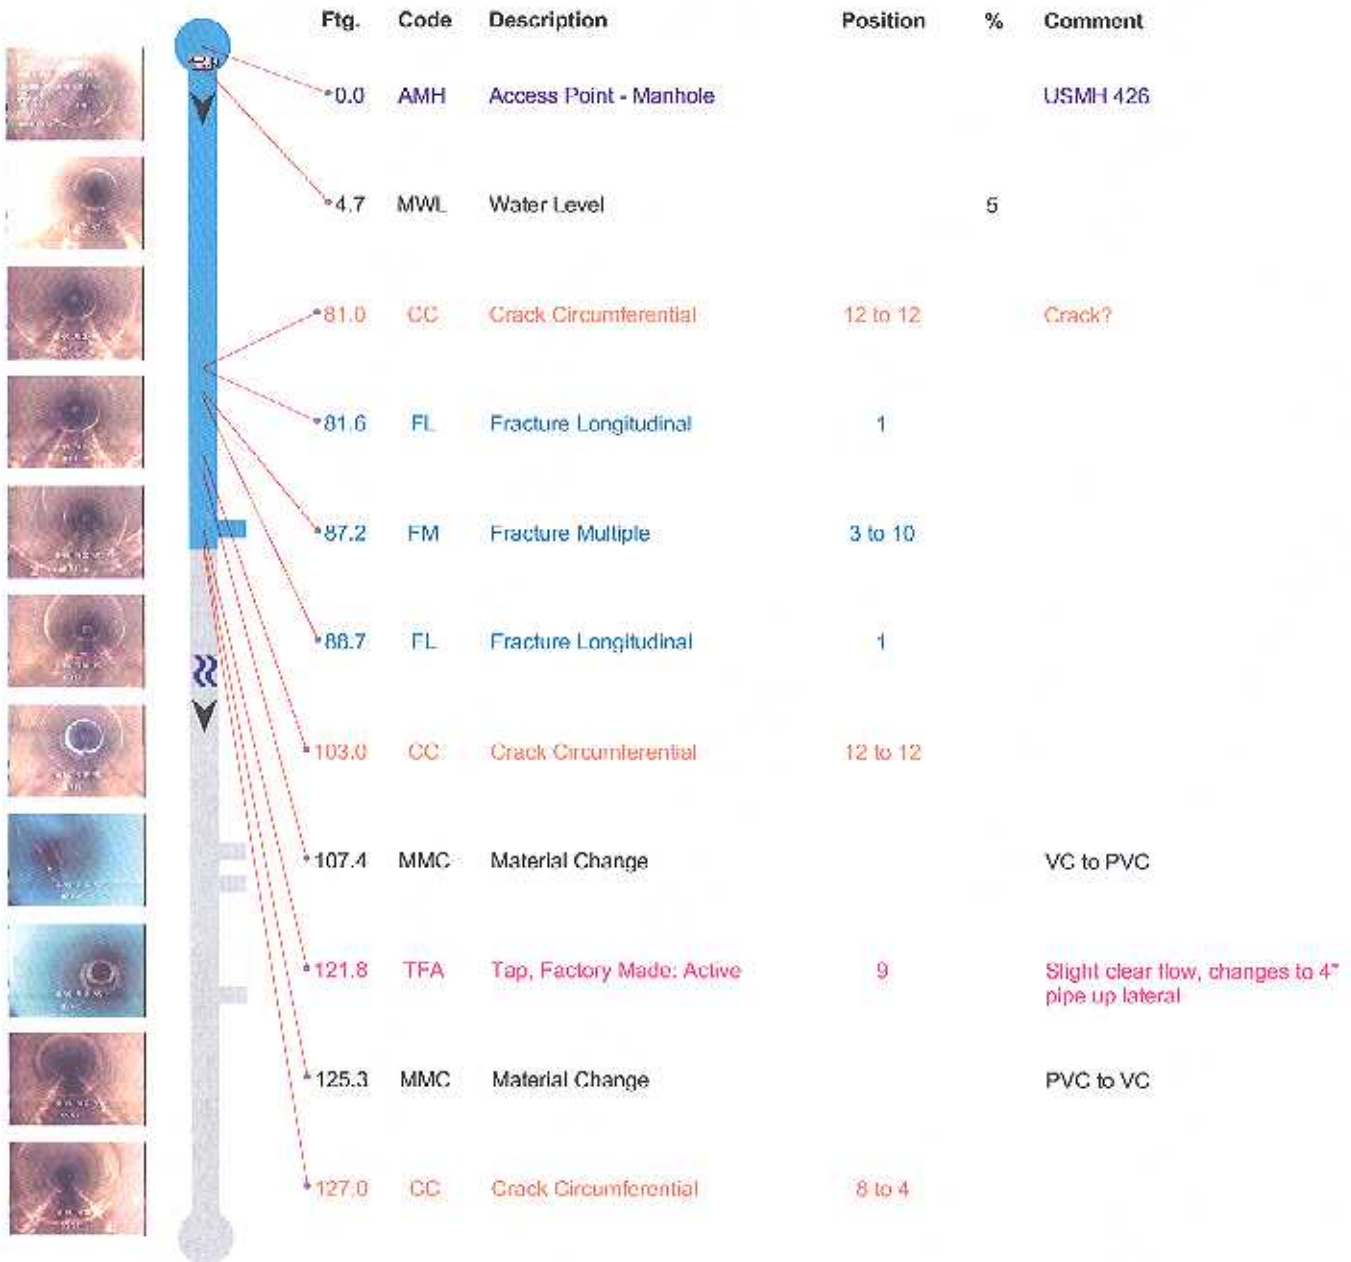
U: 426

Surveyors name Suncoast/JPY	Certificate Number 02-080	System Owner City of Camp Shelby	Survey Customer City of Camp Shelby	Drainage Area	Sheet 1
P/O No. 557	Pipeline Segment Reference 426 - 425	Date 1/16/2006	Time 12:00:00 AM	Location (Street Name and number) Jackson Ave.	Locality Camp Shelby, MS
Further Location details Bldg. 704		Upstream Manhole Number 426	Rim to Invert 3.58	Grade to Invert	Rim to Grade
Downstream Manhole Number 425	Rim to Invert 5.17	Grade to Invert	Rim to Grade	Use of Sewer Sanitary	Direction Downstream
				Flow Control Not controlled	Height 8
Width 8	Shape Circular	Material Vitrified Clay Pipe	Ln. Method	Pipe Joint Length 3	Total Length 296
				Length Surveyed 300.7	Year Laid
				Year Rehabilitated	Media # / VTR Start Tape 3221
Purpose Infiltration/Inflow Investigation	Sewer Category	Pre-Cleaning Heavy Cleaning	Cleaned 1/16/2006	Weather Dry	Additional Information VHS# 00:59:25, DSMH 425 is a drop Invert at 5.17 to floor at 7.07

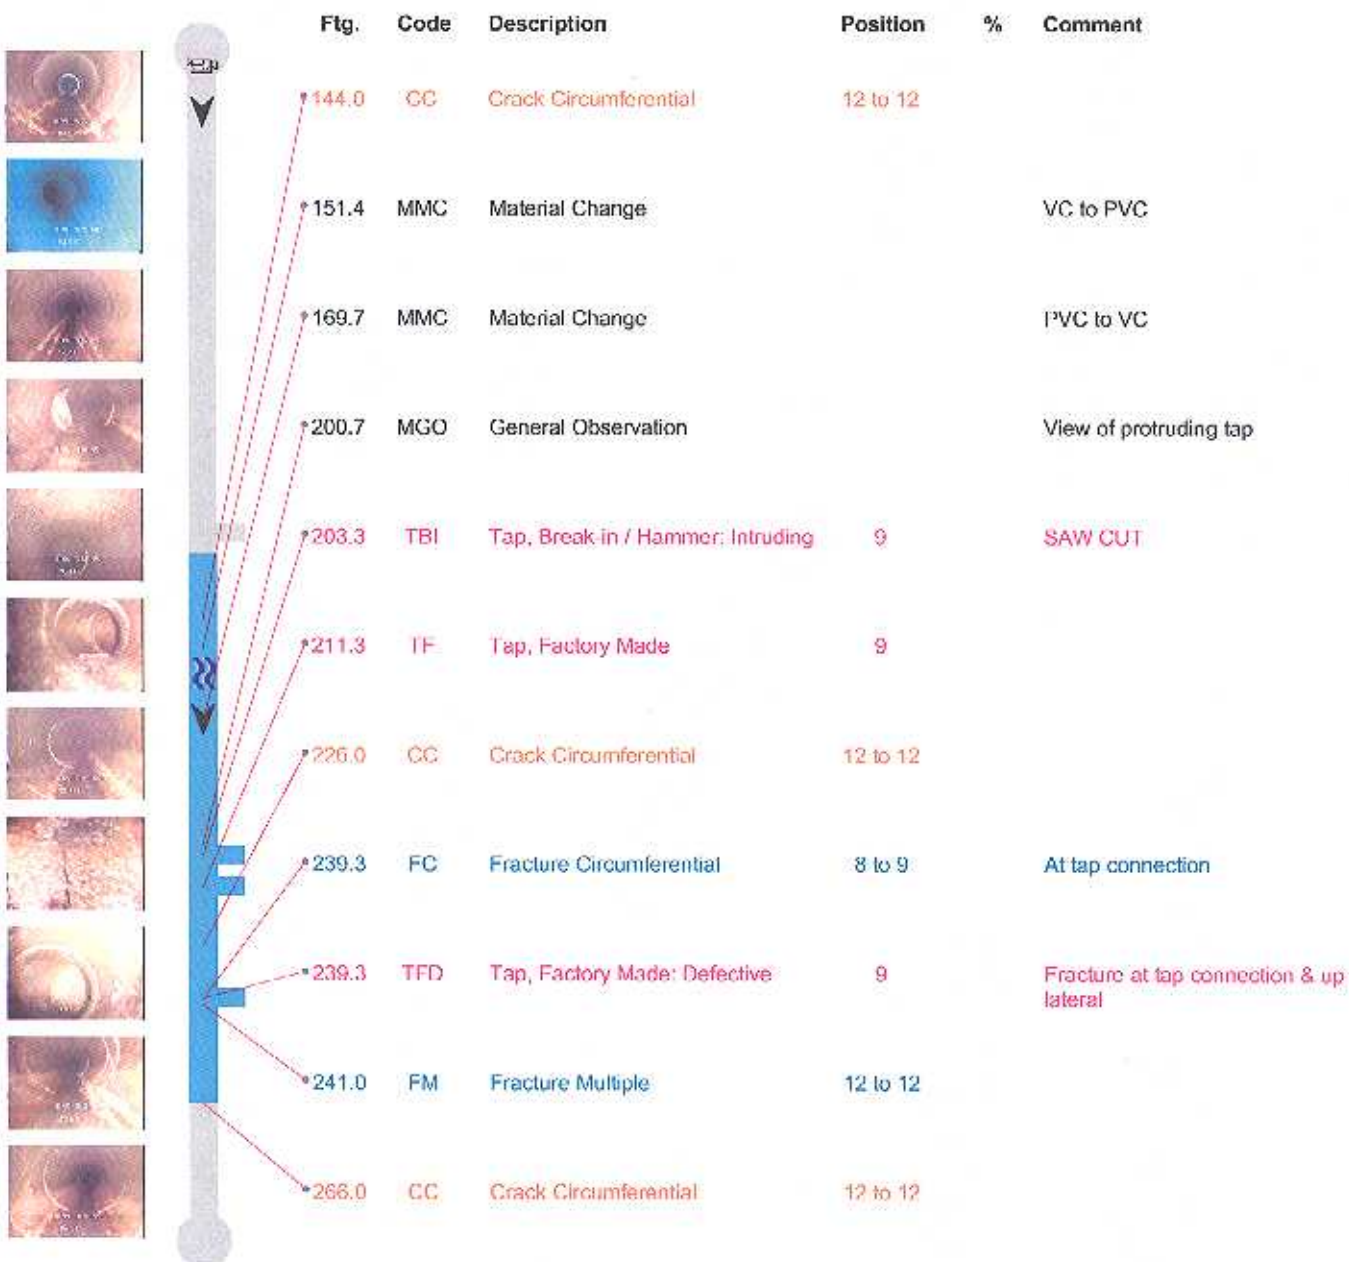
U: 426

Surveyors name Suncoast/PY	Certificate Number 02-060	System Owner City of Camp Shelby	Survey Customer City of Camp Shelby	Drainage Area	Sheet 2
P/O No. 557	Pipeline Segment Reference 426 - 425	Date 1/16/2006	Time 12:00:00 AM	Location (Street Name and number) Jackson Ave.	Locality Camp Shelby, MS
Further Location details Bldg. 704		Upstream Manhole Number 426	Rim to Invert 3.58	Grade to Invert	Rim to Grade
Downstream Manhole Number 425	Rim to Invert 5.17	Grade to Invert	Rim to Grade	Use of Sewer Sanitary	Direction Downstream
				Flow Control Not controlled	Height 8
Width 8	Shape Circular	Material Vitrified Clay Pipe	Ln. Method	Pipe Joint Length 3	Total Length 296
				Length Surveyed 300.7	Year Laid
				Year Rehabilitated	Media # / VTR Start Tape 3221
Purpose Infiltration/Inflow Investigation	Sewer Category	Pre-Cleaning Heavy Cleaning	Cleaned 1/16/2006	Weather Dry	Additional Information VHS# 00:59:26, DSMH 425 is a drop invert at 5.17 to floor at 7.67

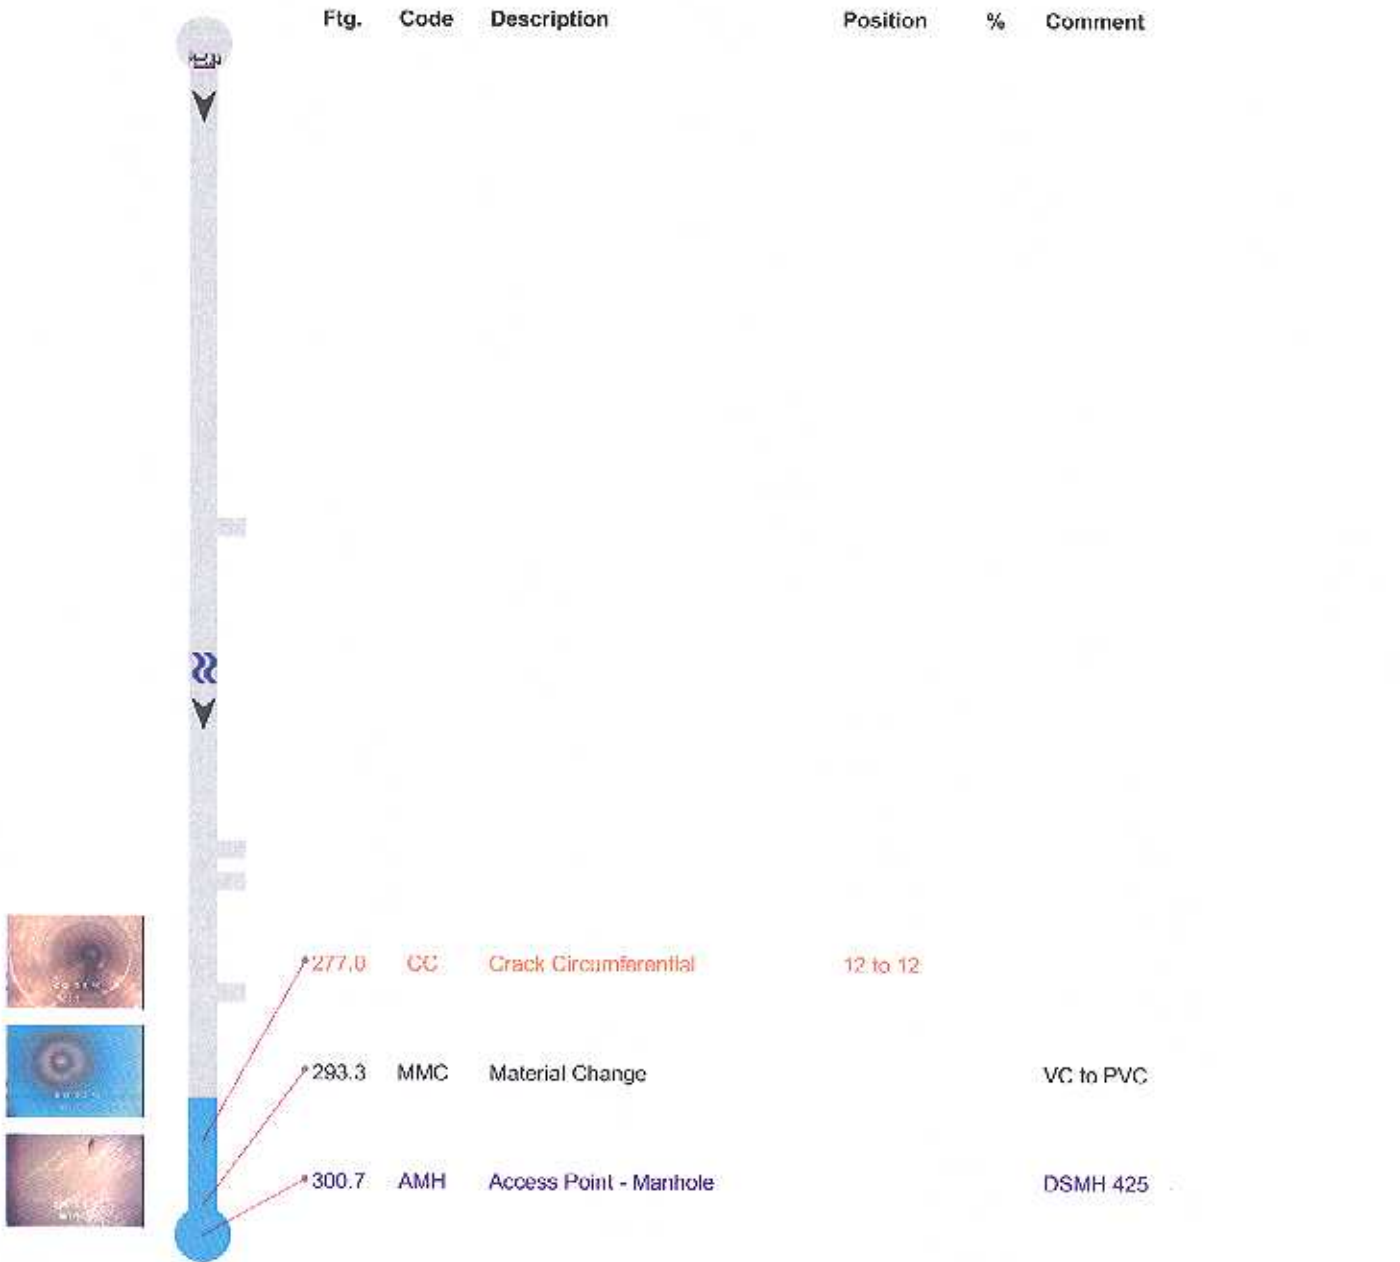
U: 426

Surveyors name Suncoast/PY	Certificate Number 02-060	System Owner City of Camp Shelby	Survey Customer City of Camp Shelby	Drainage Area	Sheet 3				
PIQ No. 557	Pipeline Segment Reference 426 - 425	Date 1/16/2006	Time 12:00:00 AM	Location (Street Name and number) Jackson Ave.	Locality Camp Shelby, MS				
Further Location details Bldg_704		Upstream Manhole Number 426	Rim to Invert 3.58	Grade to Invert	Rim to Grade				
Downstream Manhole Number 425	Rim to Invert 5.17	Grade to Invert	Rim to Grade	Use of Sewer Sanitary	Direction Downstream	Flow Control Not controlled	Height 8		
Width 8	Shape Circular	Material Vitrified Clay Pipe	Ln. Mottled	Pipe Joint Length 3	Total Length 296	Length Surveyed 300.7	Year Laid	Year Rehabilitated	Media # / VTR Start Tape 3221
Purpose Infiltration/Inflow Investigation	Sewer Category	Pre-Cleaning Heavy Cleaning	Cleaned 1/16/2006	Weather Dry	Additional Information VHS# 00:59:25, DSMH 425 is a drop invert at 5.17 to floor at 7.67

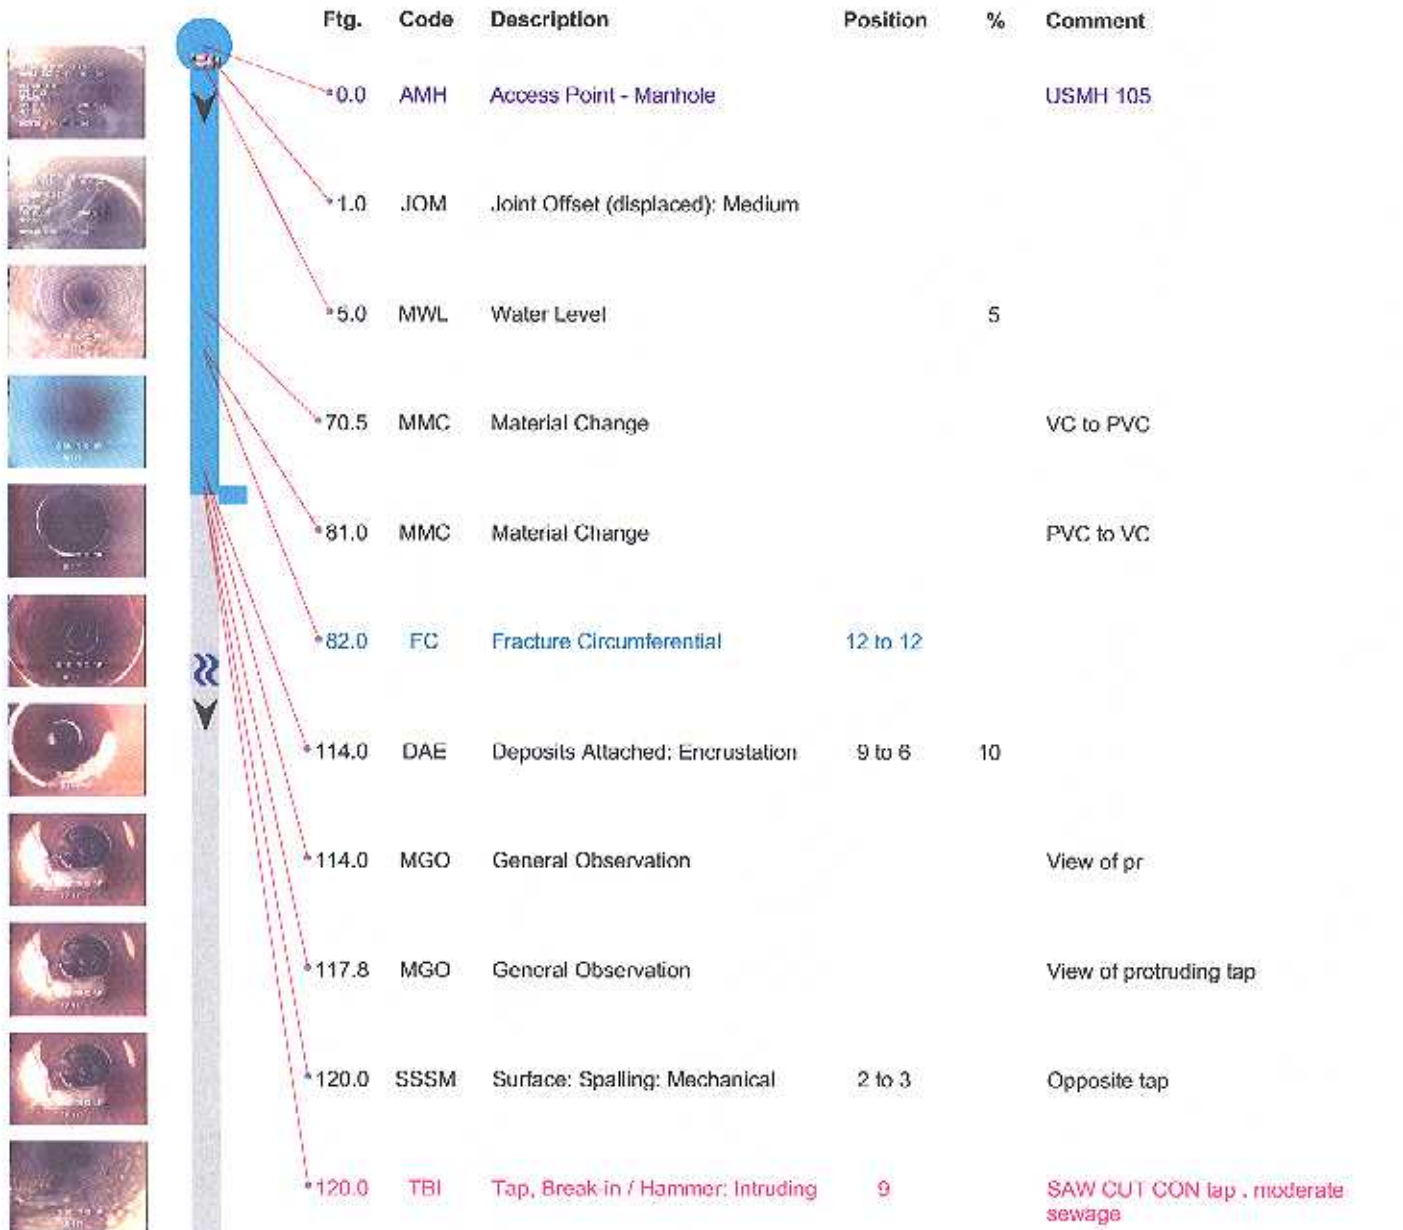
U: 105

Surveyors name Suncoast/PY	Certificate Number 02-060	System Owner City of Camp Shelby	Survey Customer City of Camp Shelby	Drainage Area	Sheet 1
PIO No. 557	Pipeline Segment Reference 105 - 104	Date 1/16/2006	Time 12:00:00 AM	Location (Street Name and number) 30th St.	Locality Camp Shelby, MS
Further Location details		Upstream Manhole Number 105	Rim to Invert 7.67	Grade to Invert	Rim to Grade
Downstream Manhole Number 104	Rim to Invert 7.5	Grade to Invert	Rim to Grade	Use of Sewer Sanitary	Direction Downstream
				Flow Control Not controlled	Height 8
Width 8	Shape Circular	Material Vitrified Clay Pipe	Ln. Method	Pipe Joint Length 3	Total Length 362
				Length Surveyed 318.4	Year Laid
				Year Rehabilitated	Media # / VTR Start Tape 3221
Purpose Infiltration/Inflow Investigation	Sewer Category	Pre-Cleaning Heavy Cleaning	Cleaned 1/16/2006	Weather Dry	Additional Information VHS# 01:12:16

Ftg.	Code	Description	Position	%	Comment
	136.0	FC	Fracture Circumferential	12 to 12		
	138.1	MMC	Material Change			VC to PVC
	160.0	MMC	Material Change			PVC to VC
	163.0	RFJ	Roots, Fine: Joint	9		
	170.0	RFJ	Roots, Fine: Joint	8		
	179.0	FC	Fracture Circumferential	4 to 11		
	179.0	RFJ	Roots, Fine: Joint	10 to 2		
	182.0	RFJ	Roots, Fine: Joint	8 to 10		
	225.0	RMJ	Roots, Medium, Joint	10 to 2	20	
	231.0	RMJ	Roots, Medium, Joint	8 to 4	15	
	253.4	RFJ	Roots, Fine: Joint	8 to 10

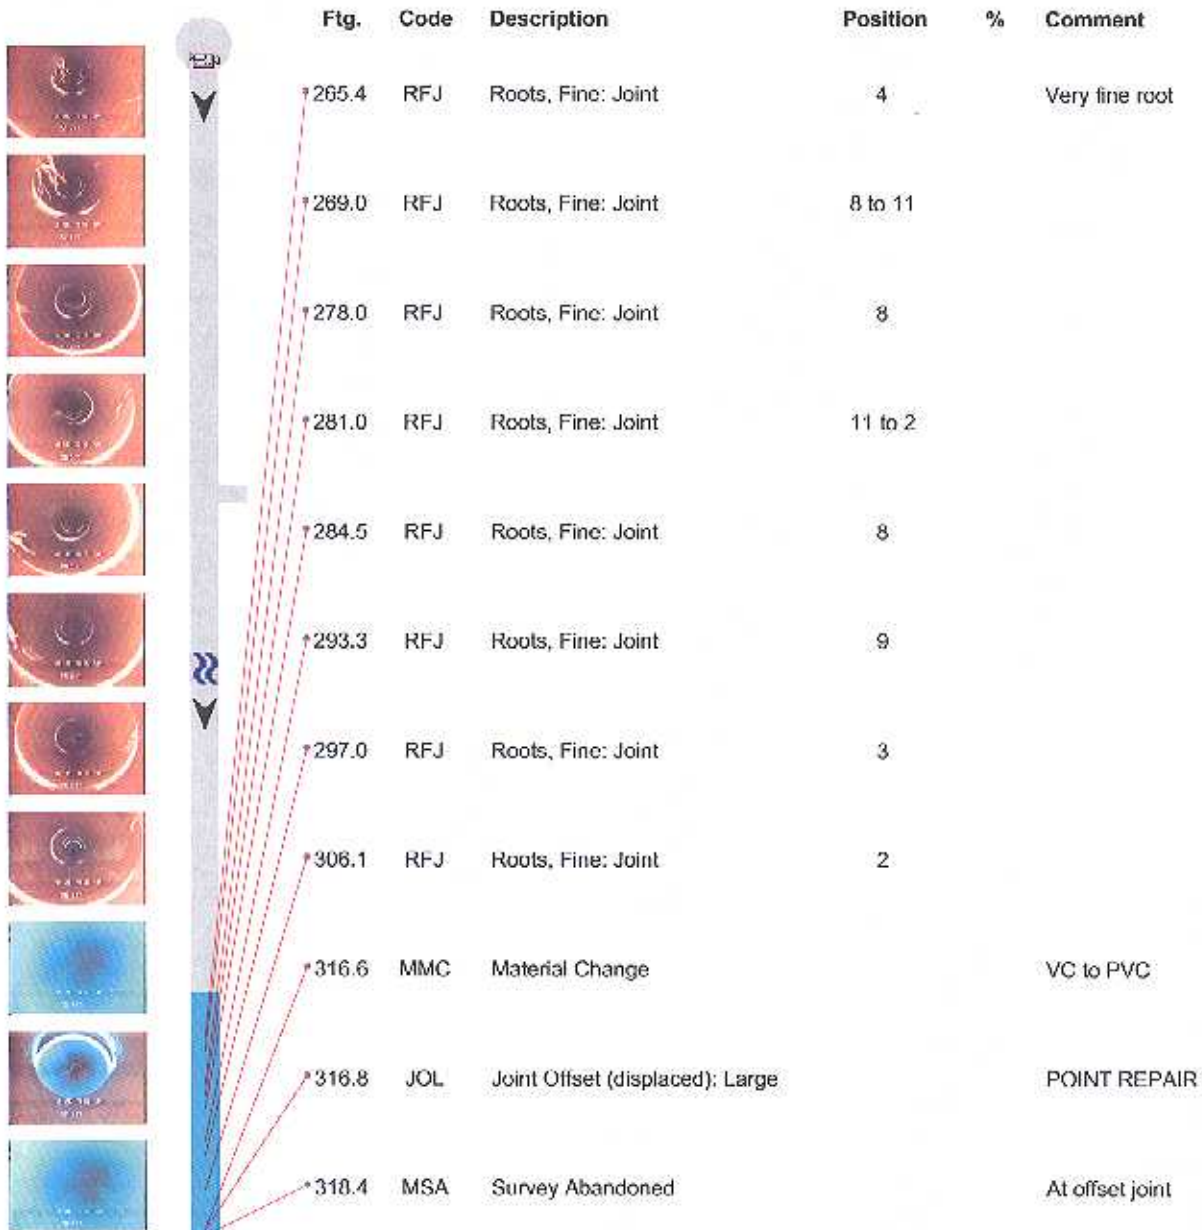
U: 105

Surveyors name Suncoast/PY	Certificate Number 02-000	System Owner City of Camp Shelby	Survey Customer City of Camp Shelby	Drainage Area	Street 3
P/O No. 557	Pipeline Segment Reference 105 - 104	Date 1/16/2006	Time 12:00:00 AM	Location (Street Name and number) 30th St	Locality Camp Shelby, MS
Further Location details		Upstream Manhole Number 105	Rim to Invert 7.87	Grade to Invert	Rim to Grade
Downstream Manhole Number 104	Rim to Invert 7.5	Grade to Invert	Rim to Grade	Use of Sewer Sanitary	Direction Downstream
Flow Control Not controlled	Height 3				
Width 8	Shape Circular	Material Vitrified Clay Pipe	Ln. Method	Pipe Joint Length 3	Total Length 382
Length Surveyed 318.4	Year Laid	Year Rehabilitated	Media # / VTR Start Tape 3221		
Purpose Infiltration/Inflow Investigation	Sewer Category	Pre-Cleaning Heavy Cleaning	Cleaned 1/16/2006	Weather Dry	Additional Information VHS# 01:12:16

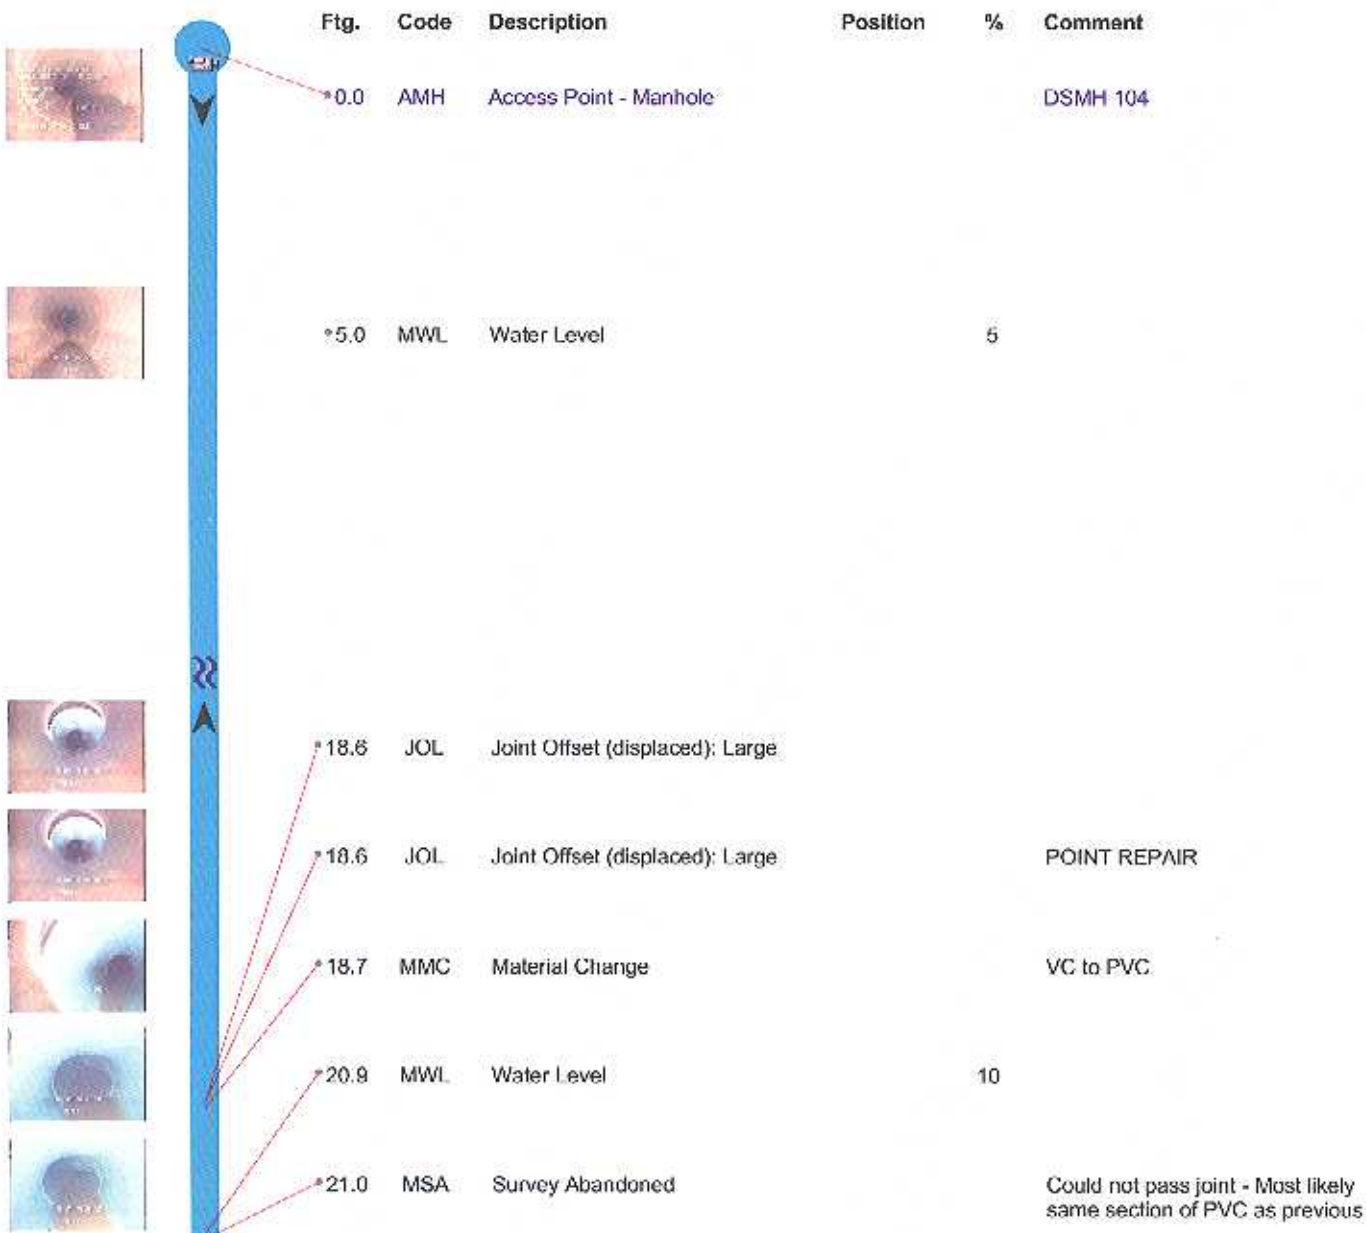
U: 105

Surveyors name Suncoast/PY	Certificate Number 02-060	System Owner City of Camp Shelby	Survey Customer City of Camp Shelby	Drainage Area	Sheet 1
P/O No. 557	Pipeline Segment Reference 105 - 104	Date 1/16/2006	Time 12:00:00 AM	Location (Street Name and number) 30th St	Locality Camp Shelby, MS
Further Location details		Upstream Manhole Number 105	Rim to Invert 7.87	Grade to Invert	Rim to Grade
Downstream Manhole Number 104rev	Rim to Invert 7.5	Grade to Invert	Rim to Grade	Use of Sewer Sanitary	Direction Upstream
				Flow Control Not controlled	Height 8
Width 8	Shape Circular	Material Vitrified Clay Pipe	Ln. Method	Pipe Joint Length 8	Total Length 882
				Length Surveyed 21	Year Laid
				Year Rehabilitated	Media # / VTR Start Tape 3221
Purpose Infiltration/Inflow Investigation	Sewer Category	Pre-Cleaning Heavy Cleaning	Cleaned 1/16/2006	Weather Dry	Additional Information VHS# 01:24:41, Reverse setup

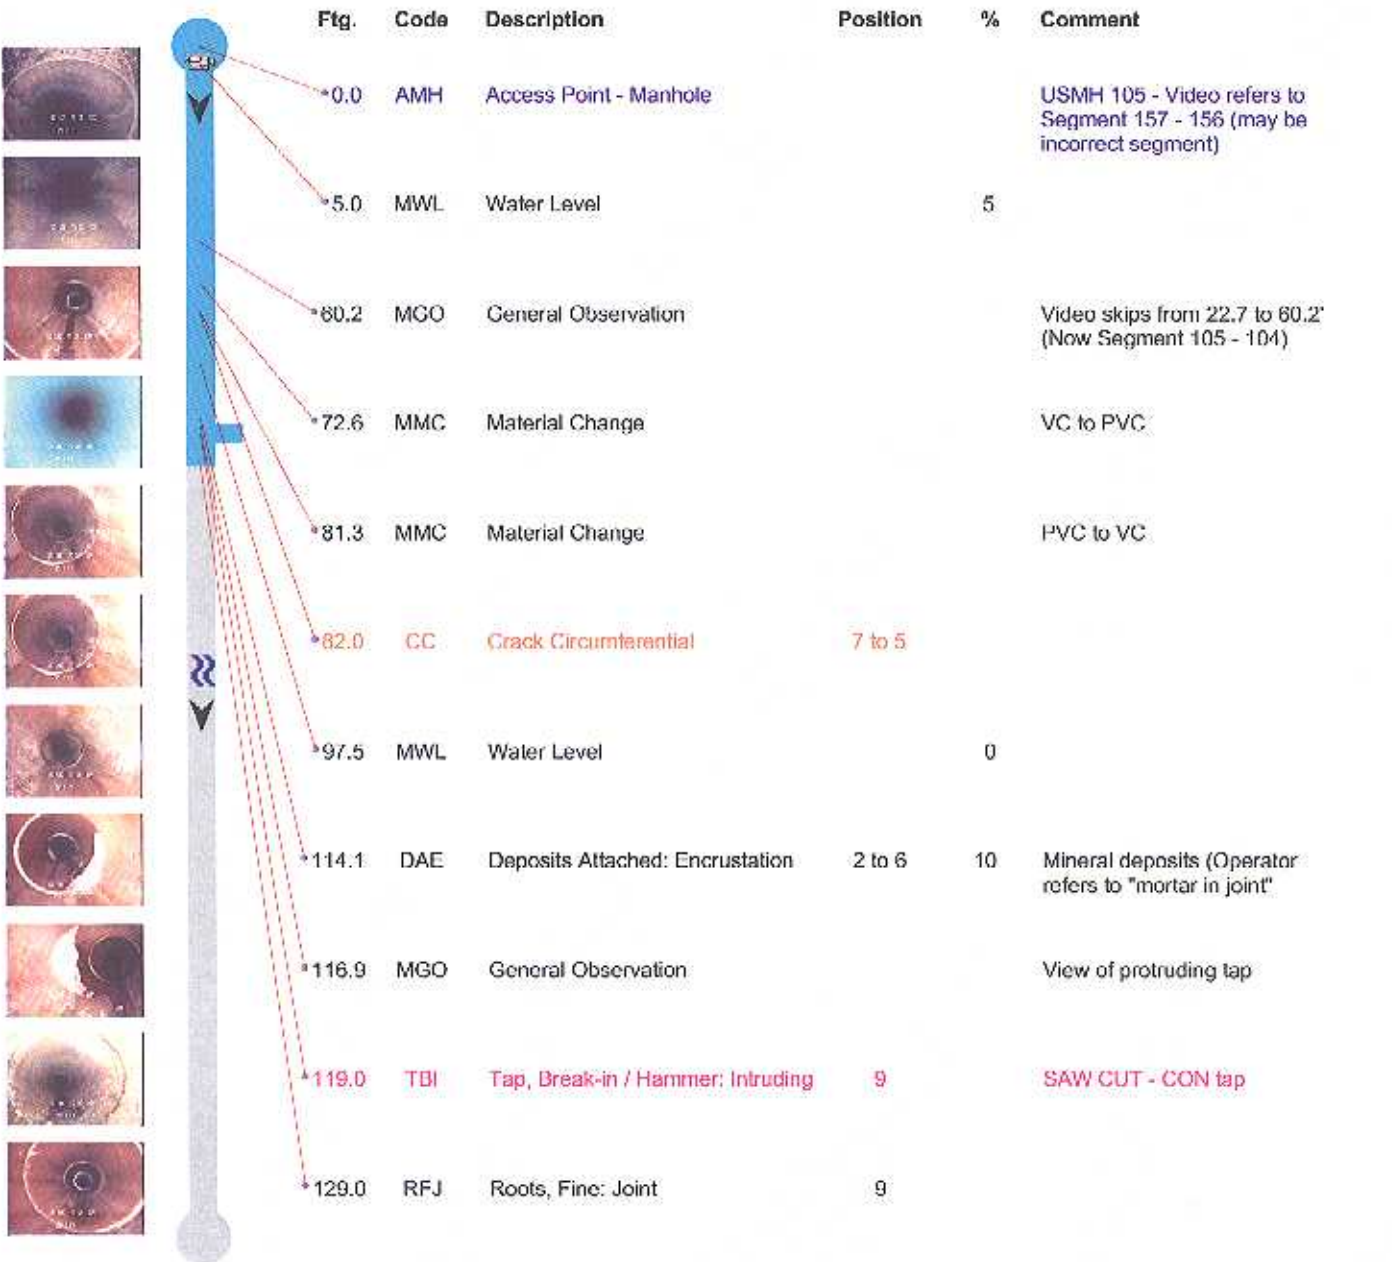
U: 105

Surveyors name Suncoast/JPY	Certificate Number 02-080	System Owner City of Camp Shelby	Survey Customer City of Camp Shelby	Drainage Area	Sheet 1
P/O No. 557	Pipeline Segment Reference 105 - 104	Date 1/19/2006	Time 12:00:00 AM	Location (Street Name and number) 30th St	Locality Camp Shelby, MS
Further Location details Bldg. 2805		Upstream Manhole Number 105	Rim to Invert 7.75	Grade to Invert	Rim to Grade
Downstream Manhole Number 104	Rim to Invert 7.58	Grade to Invert	Rim to Grade	Use of Sewer Sanitary	Direction Downstream
				Flow Control Not controlled	Height 8
Width 8	Shape Circular	Material Vitrified Clay Pipe	I.n. Method	Pipe Joint Length 3	Total Length 366
				Length Surveyed 365.9	Year Laid
				Year Rehabilitated	Media # / VTR Start Tape 3224
Purpose Infiltration/Inflow Investigation	Sewer Category	Pre-Cleaning Heavy Cleaning	Cleaned 1/19/2006	Weather Dry	Additional Information VHS# 00:00:00
