Camp Shelby, Mississippi

Evaluation CCTV Inspection Report for Sanitary Sewer Main Improvements

CCTV INSPECTION REPORT: Vol. 8

Suncoast Job #: 557

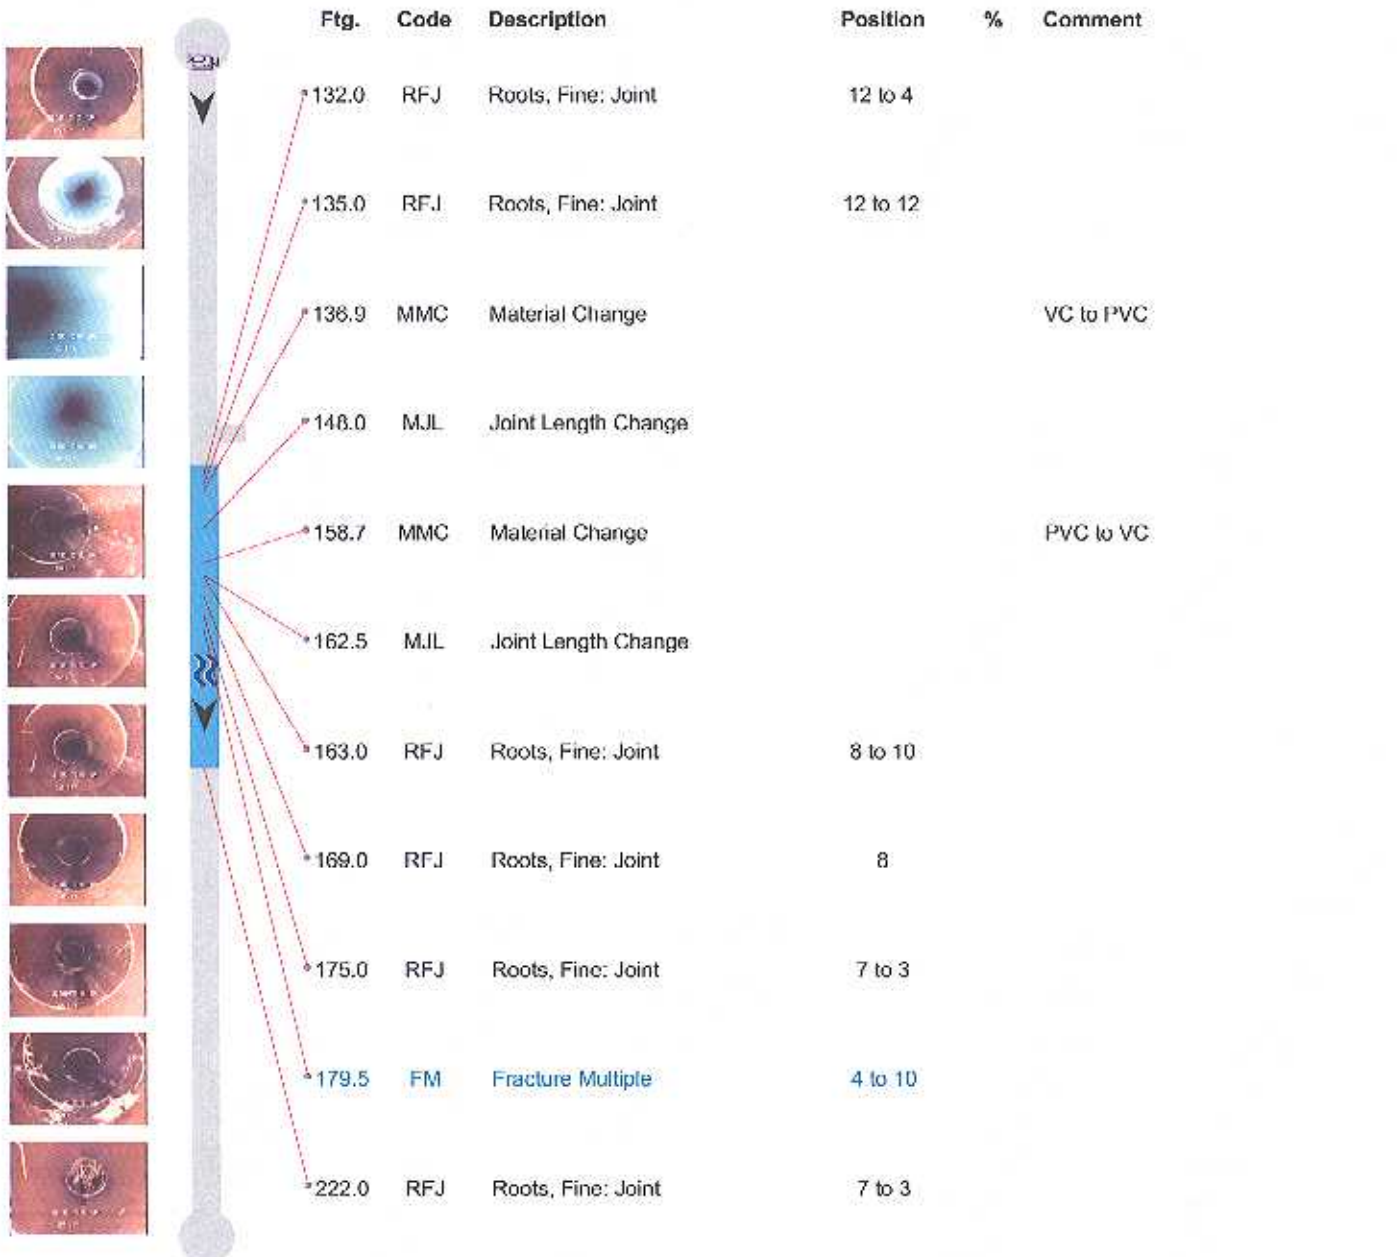
U: 105

Surveyors name Suncoast/PPY	Certificate Number 02-080	System Owner City of Camp Shelby	Survey Customer City of Camp Shelby	Drainage Area	Sheet 2
P/O No. 557	Pipeline Segment Reference 105 - 104	Date 1/19/2006	Time 12:00:00 AM	Location (Street Name and number) 30th St	Locality Camp Shelby, MS
Further Location details Bldg. 2905		Upstream Manhole Number 105	Rim to Invert 7.75	Grade to Invert	Rim to Grade
Downstream Manhole Number 104	Rim to Invert 7.58	Grade to Invert	Rim to Grade	Use of Sewer Sanitary	Direction Downstream
				Flow Control Not controlled	Height 8
Width 8	Shape Circular	Material Vitrified Clay Pipe	In. Method	Pipe Joint Length 3	Total Length 388
				Length Surveyed 385.0	Year Laid
				Year Rehabilitated	Media # / VTR Start Tape 3224
Purpose Infiltration/Inflow Investigation	Sewer Category	Pre-Cleaning Heavy Cleaning	Cleaned 1/19/2006	Weather Dry	Additional Information VHS# 00:00:00

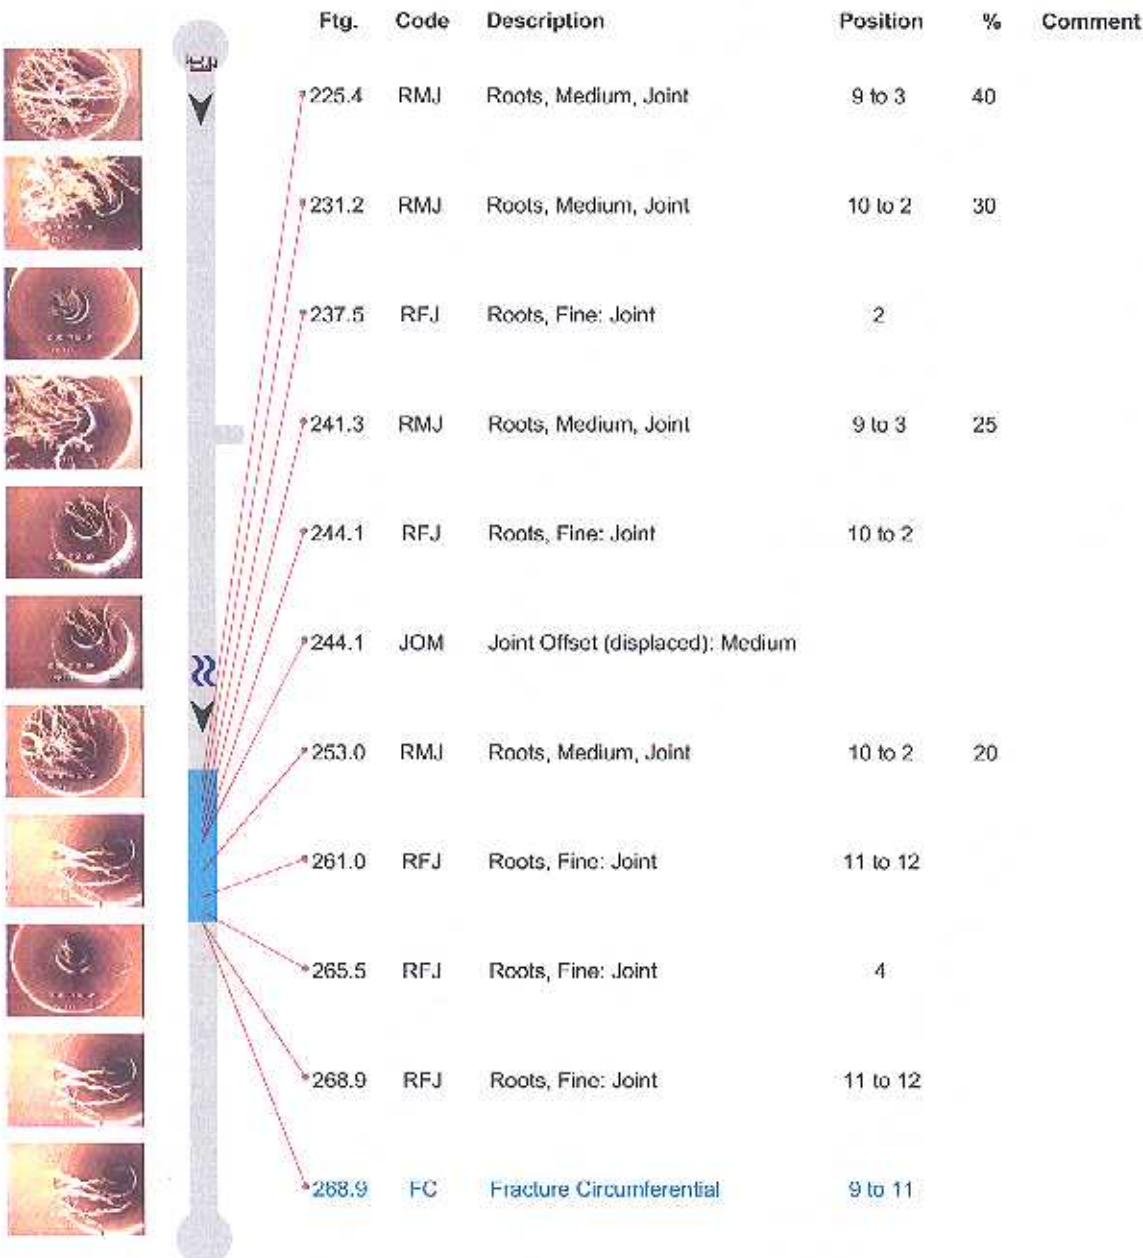
U: 105

Surveyors name Suncoast/PY	Certificate Number 02-060	System Owner City of Camp Shelby	Survey Customer City of Camp Shelby	Drainage Area	Sheet 3
P/O No. 557	Pipeline Segment Reference 105 - 104	Date 1/19/2006	Time 12:00:00 AM	Location (Street Name and number) 30th St.	Locality Camp Shelby, MS
Further Location details Bldg. 2905		Upstream Manhole Number 105	Rim to Invert 7.75	Grade to Invert	Rim to Grade
Downstream Manhole Number 104	Rim to Invert 7.38	Grade to Invert	Rim to Grade	Use of Sewer Sanitary	Direction Downstream
				Flow Control Not controlled	Height .8
Width 8	Shape Circular	Material Vitrified Clay Pipe	Ln. Method	Pipe Joint Length 3	Total Length 300
				Length Surveyed 365.9	Year Laid
				Year Rehabilitated	Media # / VTR Start Tape 3224
Purpose Infiltration/Inflow Investigation	Sewer Category	Pre-Cleaning Heavy Cleaning	Cleaned 1/19/2006	Weather Dry	Additional Information VHS# 00.00.00

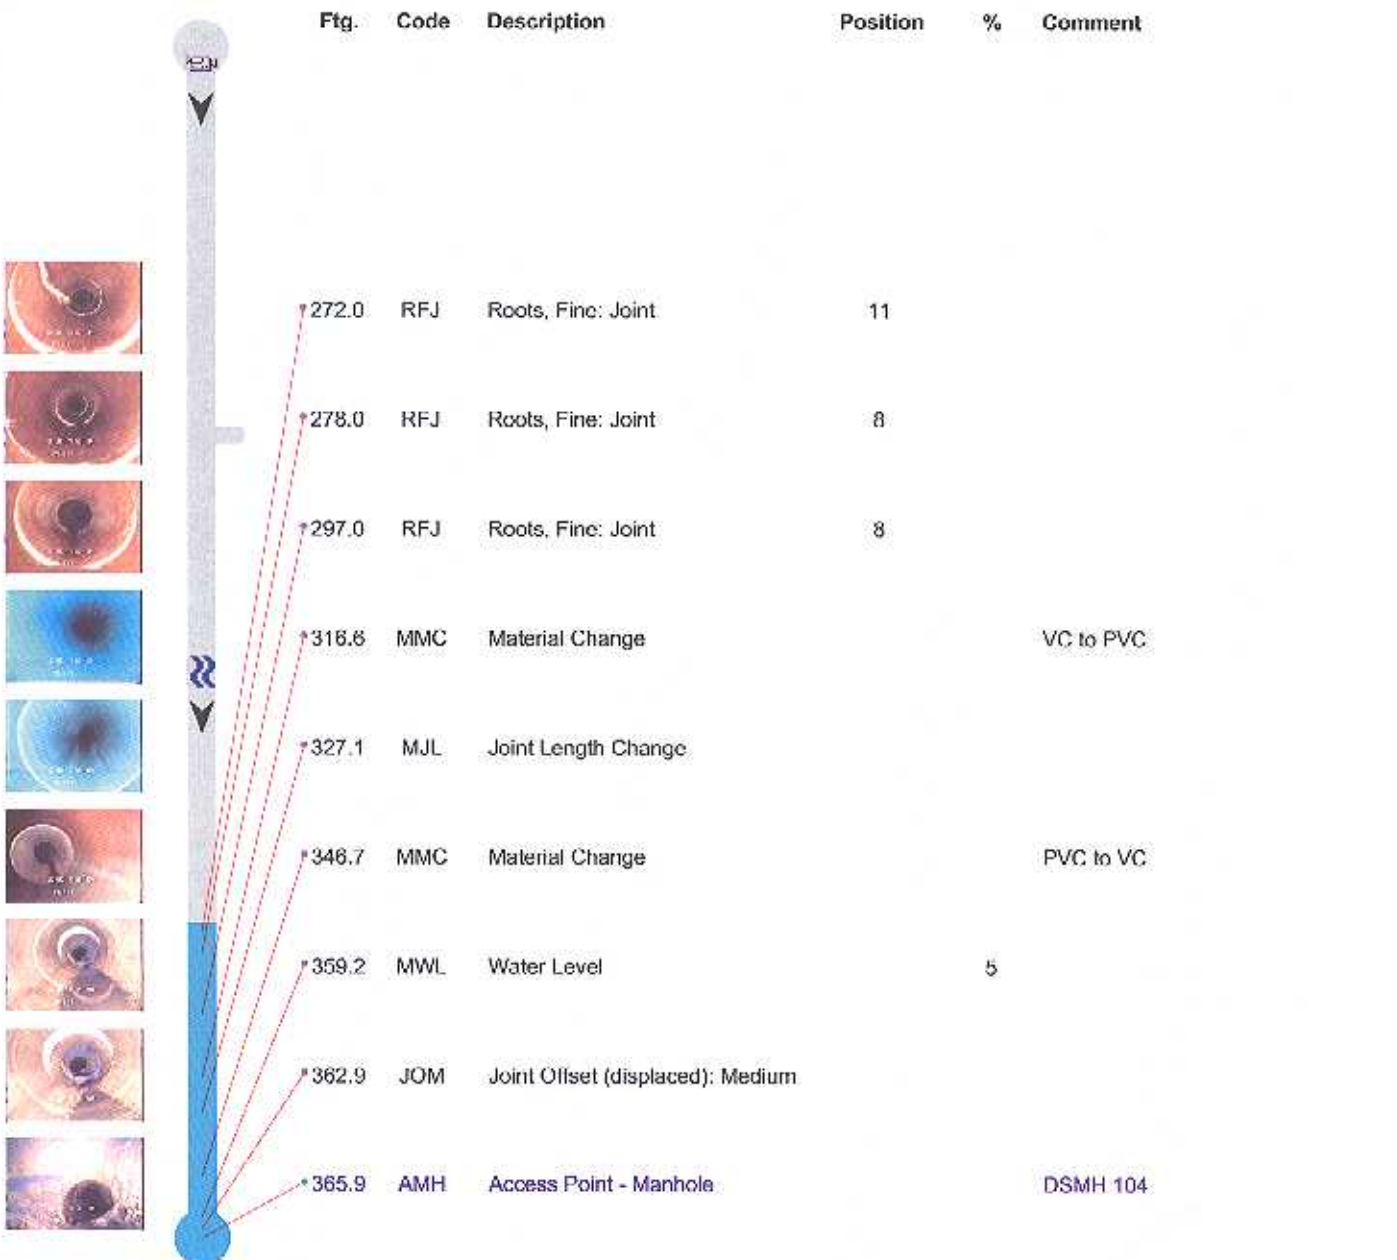
U: 105

Purpose Infiltration/Inflow Investigation	Sewer Category	Pre-Cleaning Heavy Cleaning	Cleaned 1/19/2006	Weather Dry	Additional Information VHS# 00:00:00
--	----------------	--------------------------------	----------------------	----------------	---

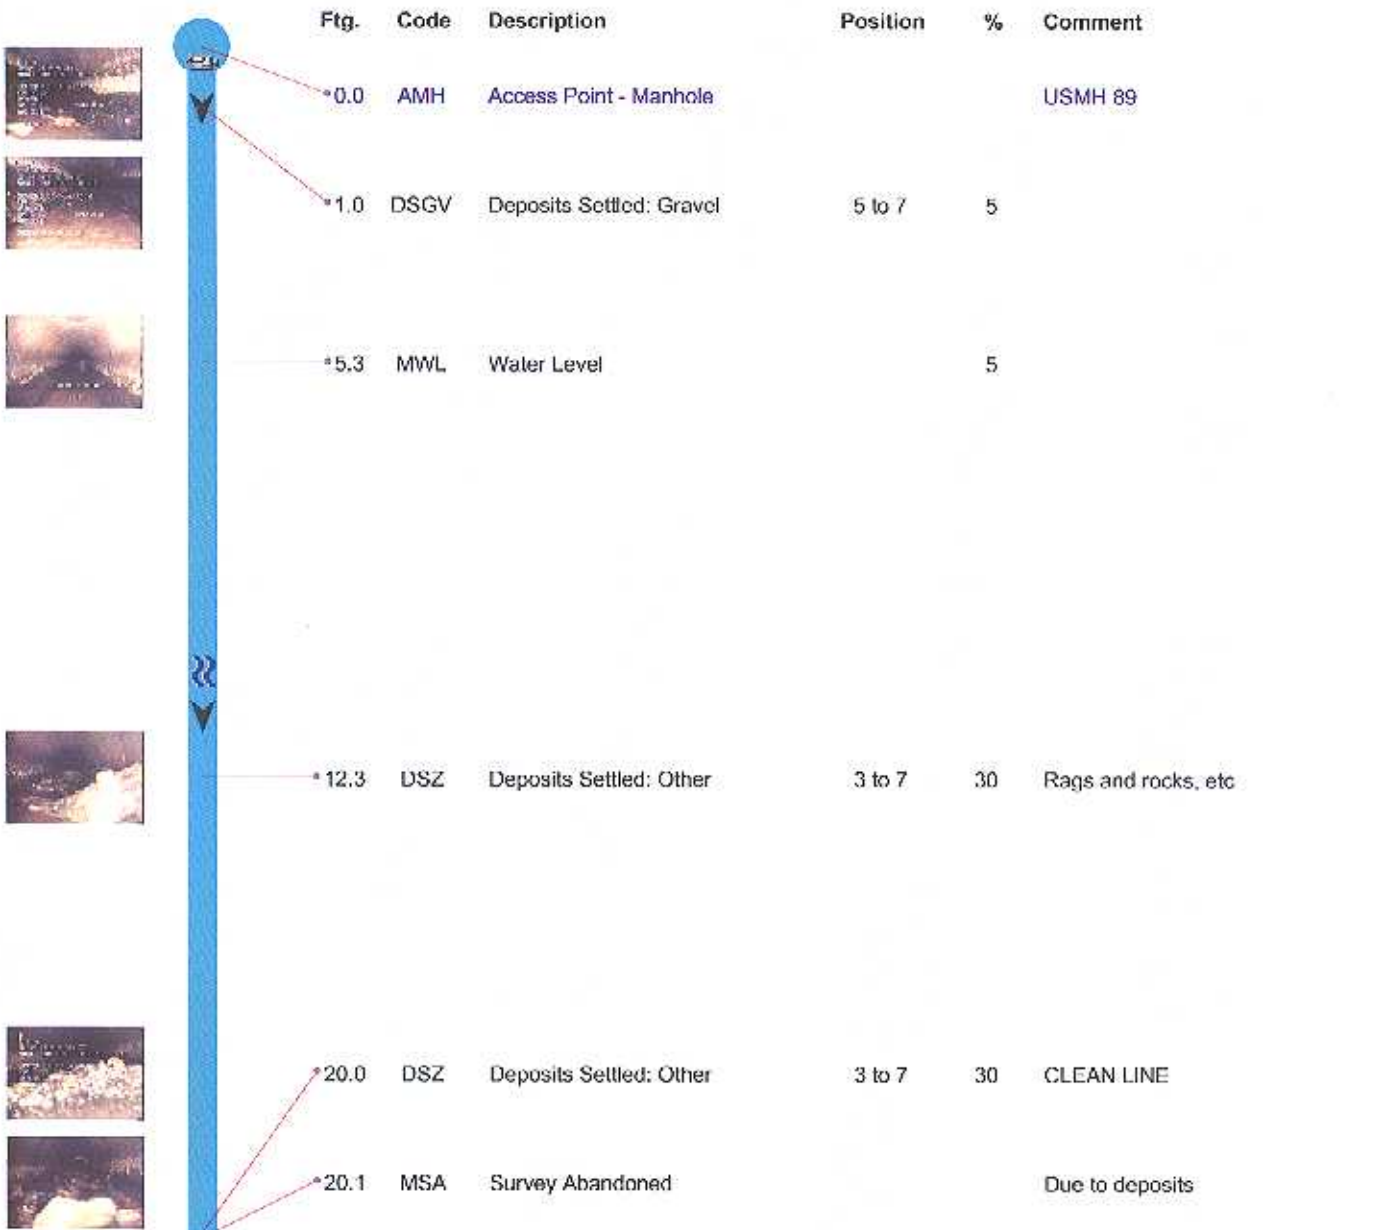
U: 89

Surveyors name Suncoast/PPY	Certificate Number 02 060	System Owner City of Camp Shelby	Survey Customer City of Camp Shelby	Drainage Area	Sheet 1				
P/O No. 557	Pipeline Segment Reference 89 - 88	Date 2/1/2006	Time 12:00:00 AM	Location (Street Name and number) Jackson Ave.	Locality Camp Shelby, MS				
Further Location details Bldg. 2735		Upstream Manhole Number 89	Rim to Invert 13.17	Grade to Invert	Rim to Grade				
Downstream Manhole Number 88	Rim to Invert 10.75	Grade to Invert	Rim to Grade	Use of Sewer Sanitary	Direction Downstream	Flow Control Plugged	Height 8		
Width 8	Shape Circular	Material Vitrified Clay Pipe	Ln. Method	Pipe Joint Length 4	Total Length 223	Length Surveyed 20.1	Year Laid	Year Rehabilitated	Media # / VTR Start Tape 3227
Purpose Infiltration/Inflow Investigation	Sewer Category	Pre-Cleaning Heavy Cleaning	Cleaned 2/1/2006	Weather Dry	Additional Information VHS# 00.00.00
